Hydrologic Data Collected During the 1994 Lake Mills Drawdown Experiment, Elwha River, Washington

U.S. GEOLOGICAL SURVEY
Water-Resources Investigations Report 99-4215

By DALLAS CHILDERS, DAVID L. KRESCH, STEVEN A. GUSTAFSON,
TIMOTHY J. RANDLE*, JAMES T. MELENA*, AND BRIAN CLUER#

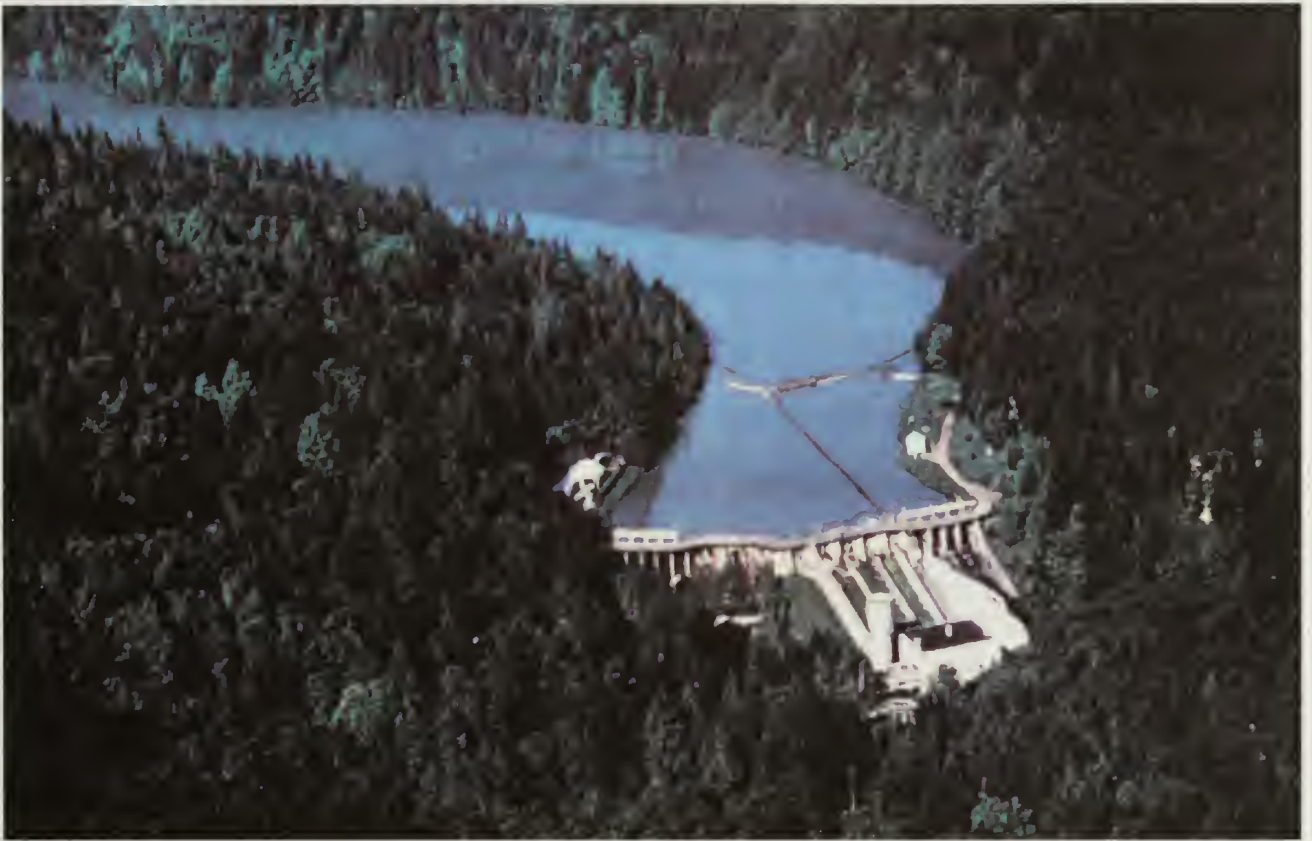
Figure 1. Elwha Dam (left), powerhouse (center), spillway channel (right), and Lake Aldwell (background). Photograph provided by the Bureau of Reclamation.

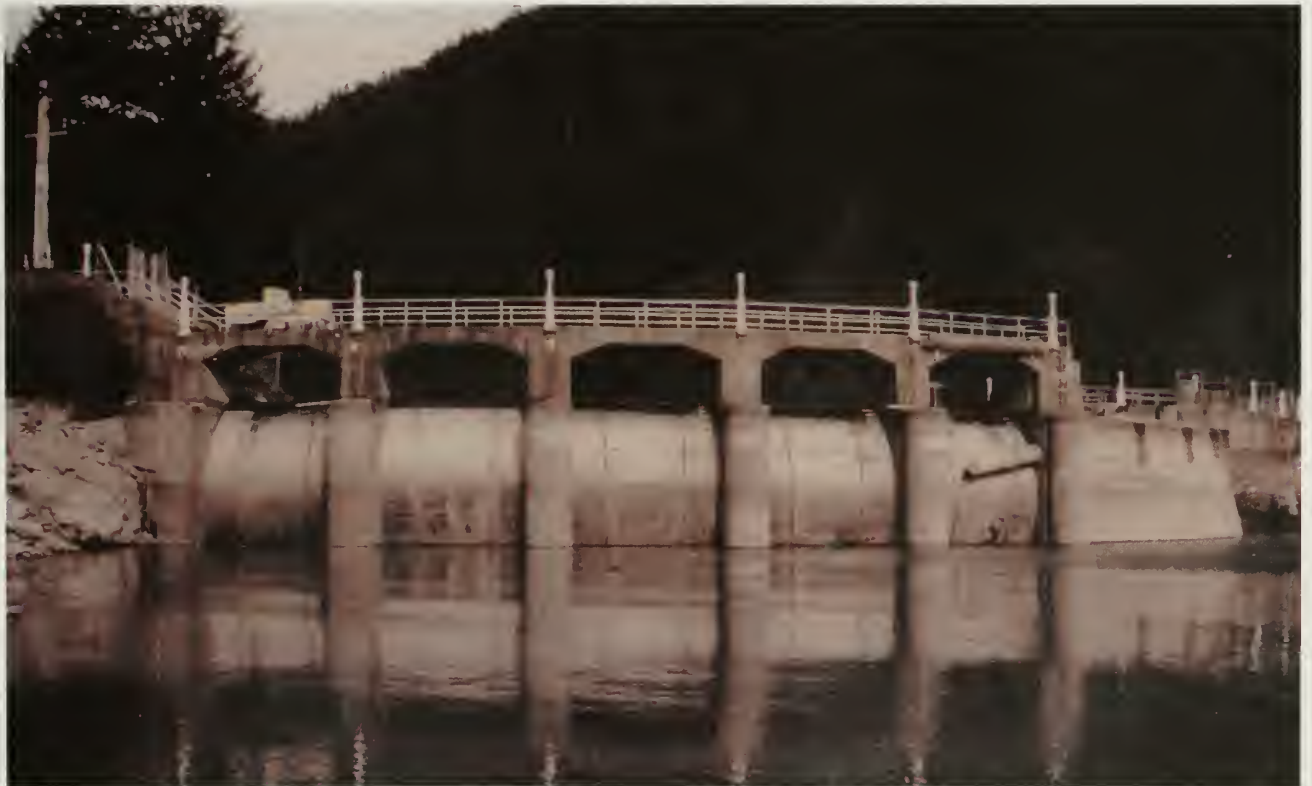
Figure 2. Glines Canyon Dam.

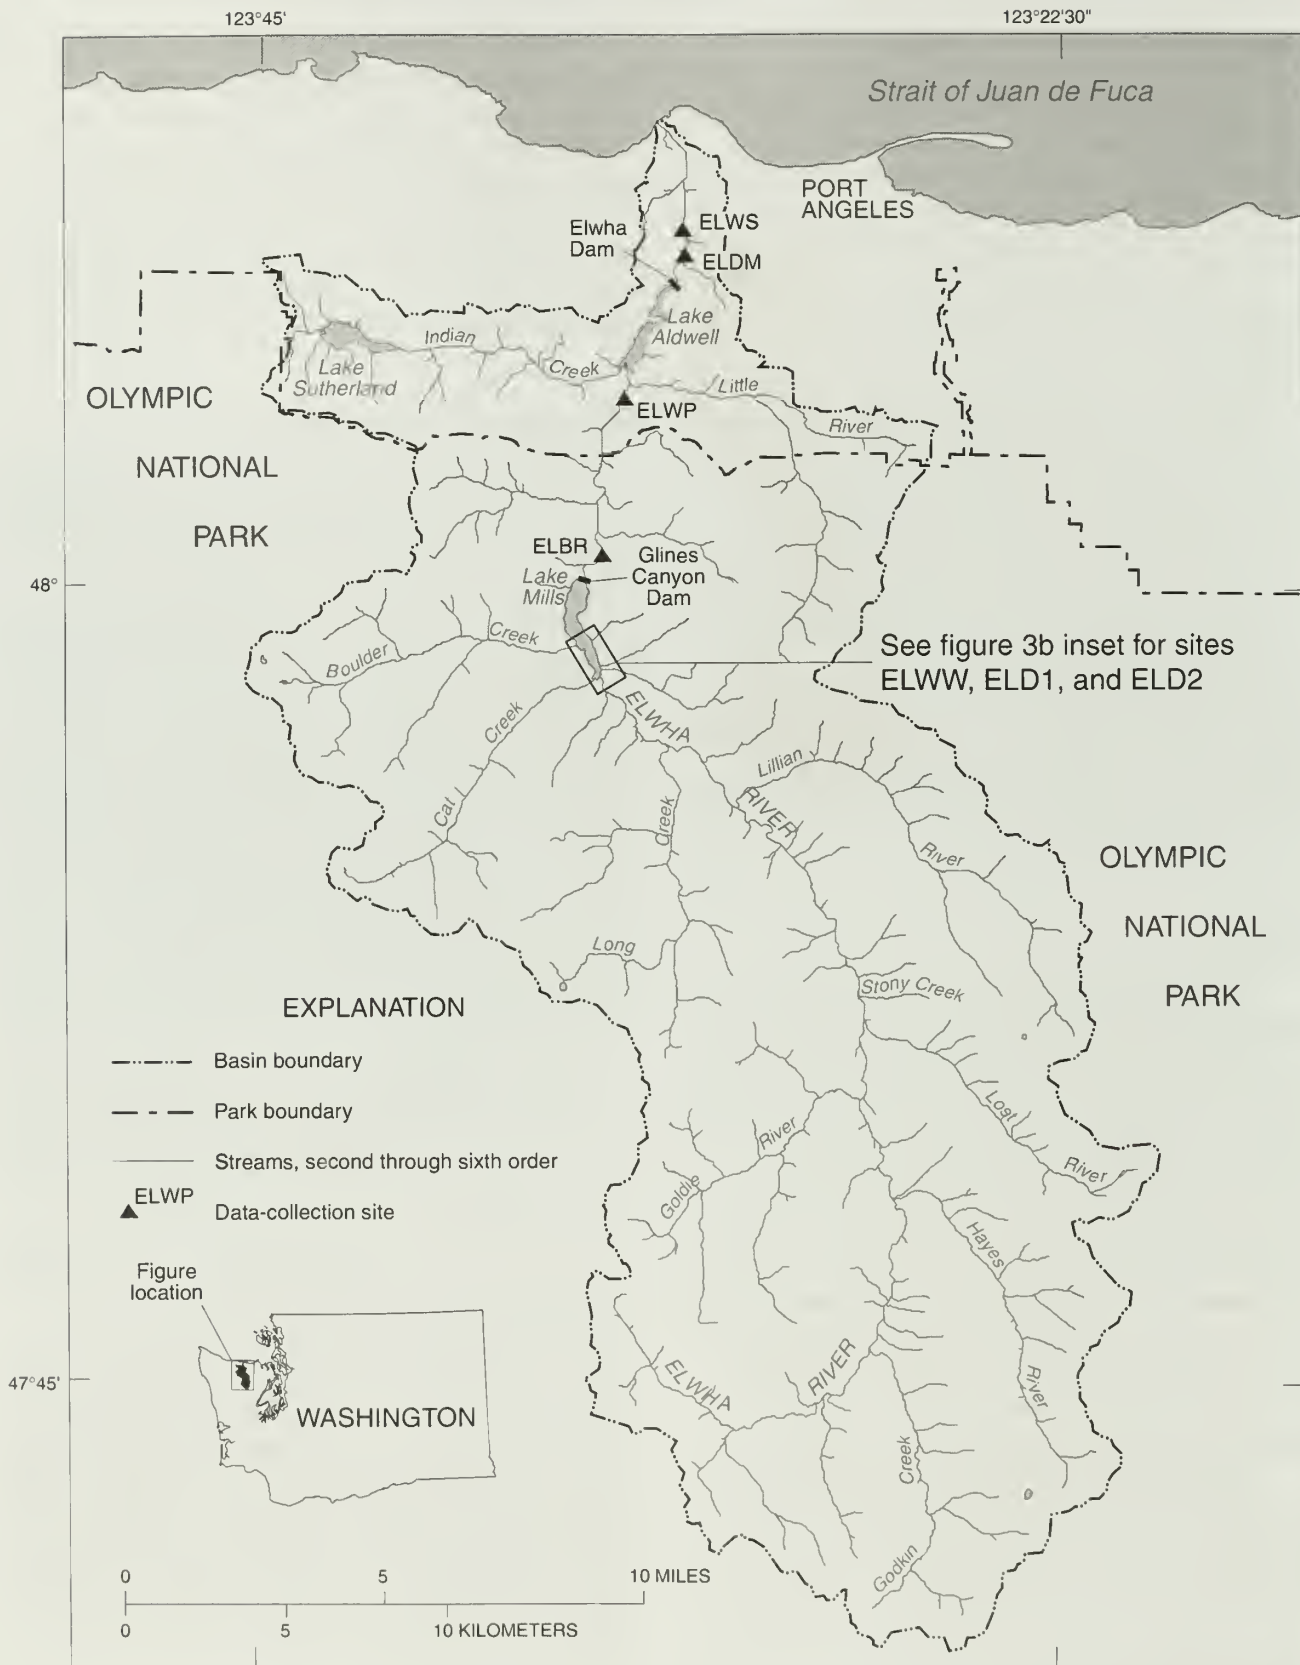
Figure 3a. Study area in the lower Elwha River Valley and locations of streamflow and sediment data-collection sites ELBR, ELWP, ELDM, and ELWS. The USGS station number and name for each site are given in table 1a. The types of data collected at each site are given in table 1b.

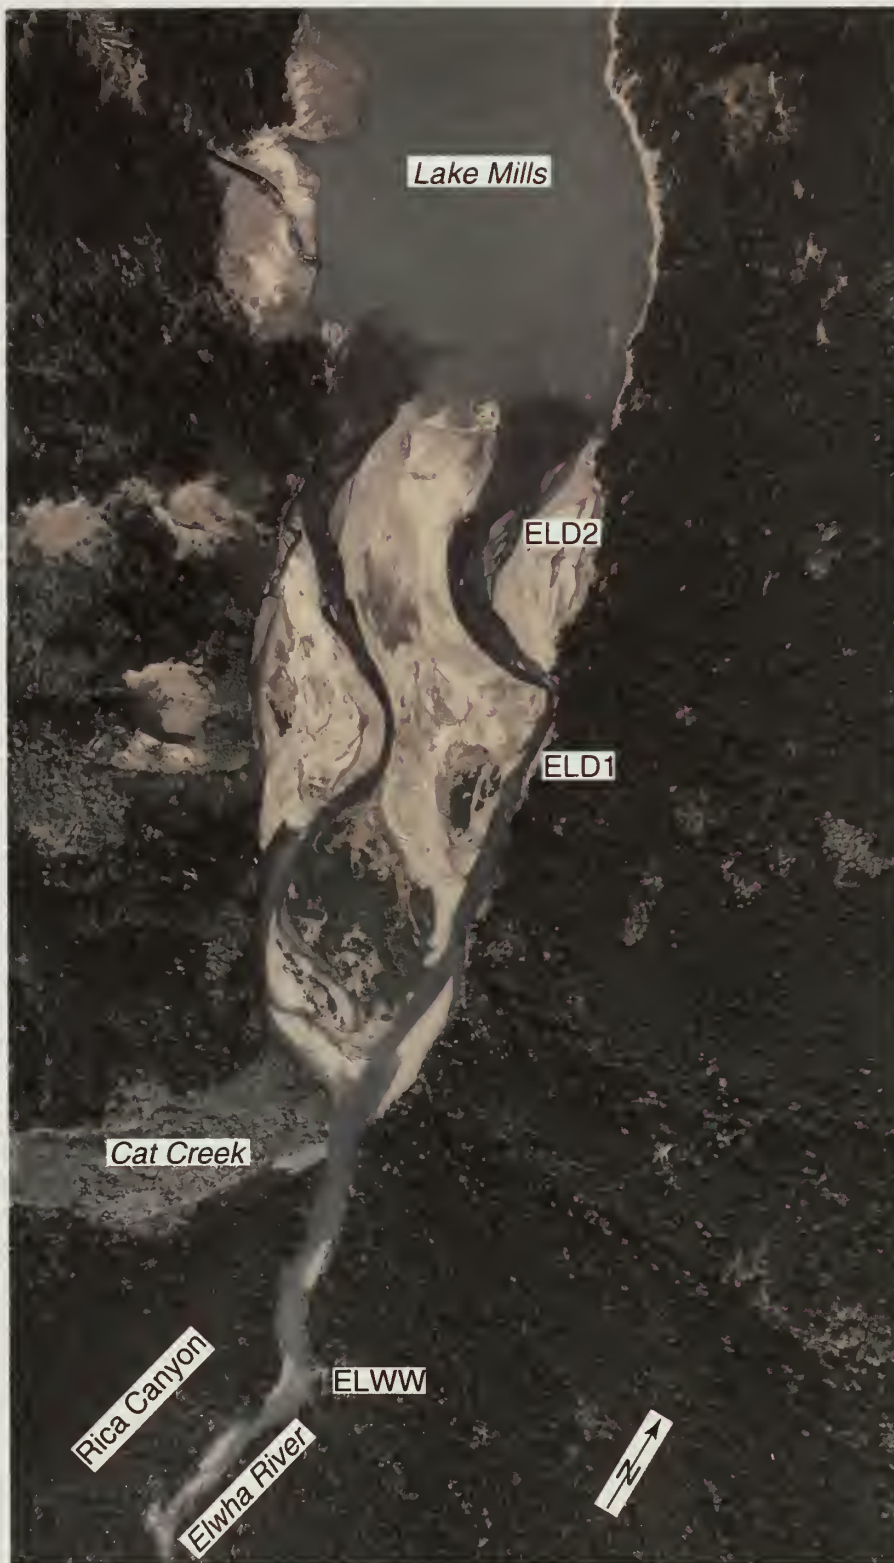
Figure 3b. Locations of streamflow and sediment data-collection sites ELWW, ELD1, and ELD2. Aerial photograph was taken on April 16, 1994, at time of full 18-foot drawdown of Lake Mills. Elwha River is flowing from south to north and has divided into a right (east) channel and a left (west) channel in the delta area. Photograph provided by the Bureau of Reclamation.

The largest rocks were concentrated in the upper part of the delta, in the Cat Creek fan, and in Rica Canyon (photo, fig. 3b, and map, fig. 14). The largest rocks were found in surface particle counts, which showed the maximum intermediate diameters of individual rocks to be less than 362 millimeters, with 99 percent being less than 256 millimeters. Pit samples showed similar results, with all rocks being less than 300 millimeters in size.

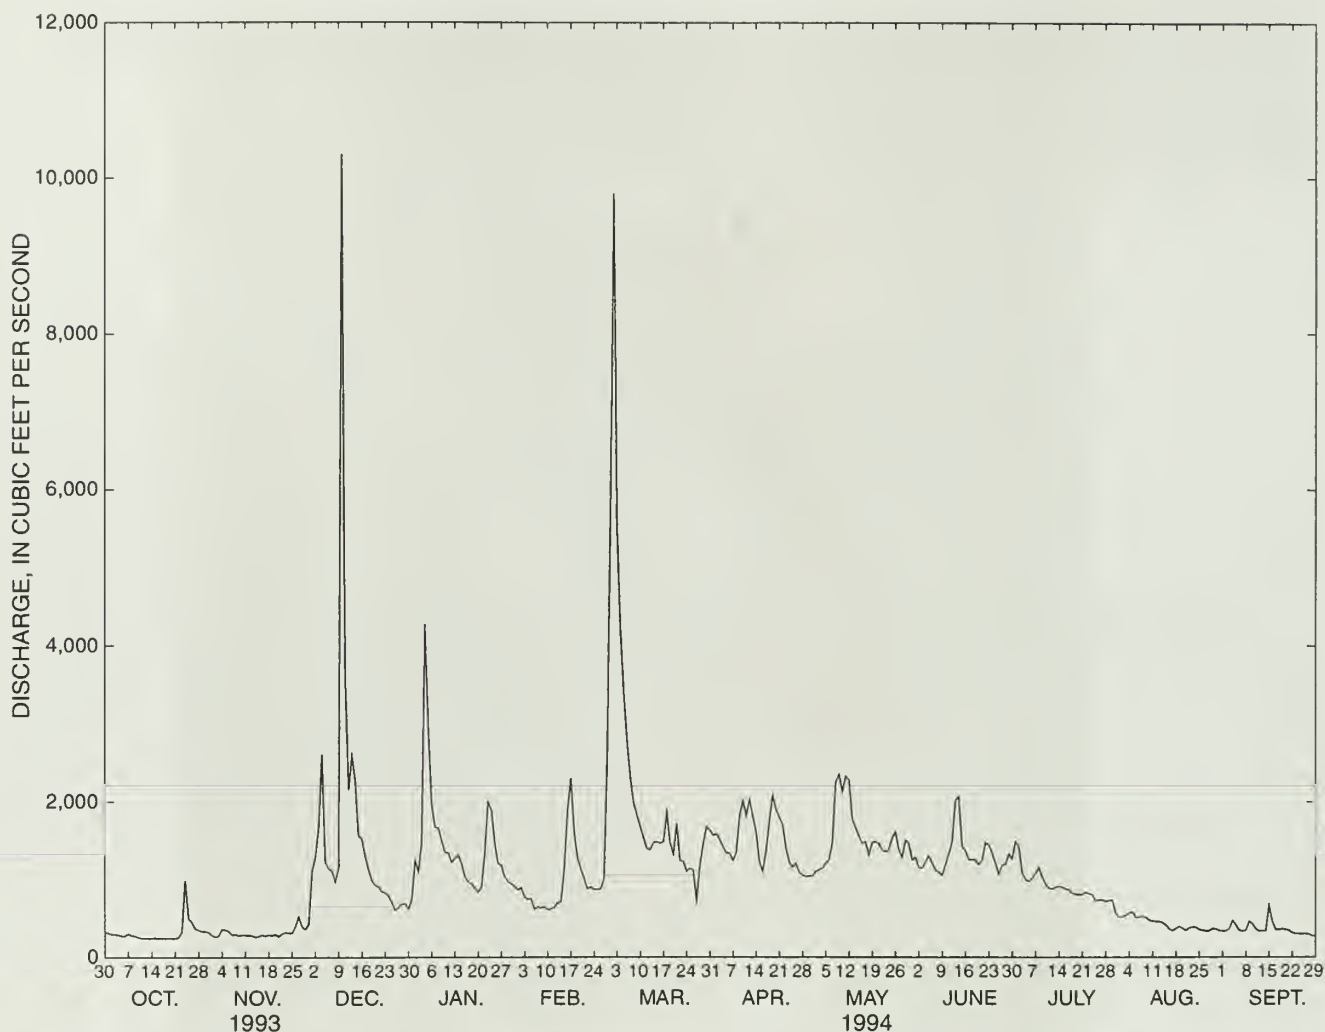
Figure 4. Daily streamflow record at site 12045500, Elwha River at McDonald Bridge (ELWP), for the 1994 water year.

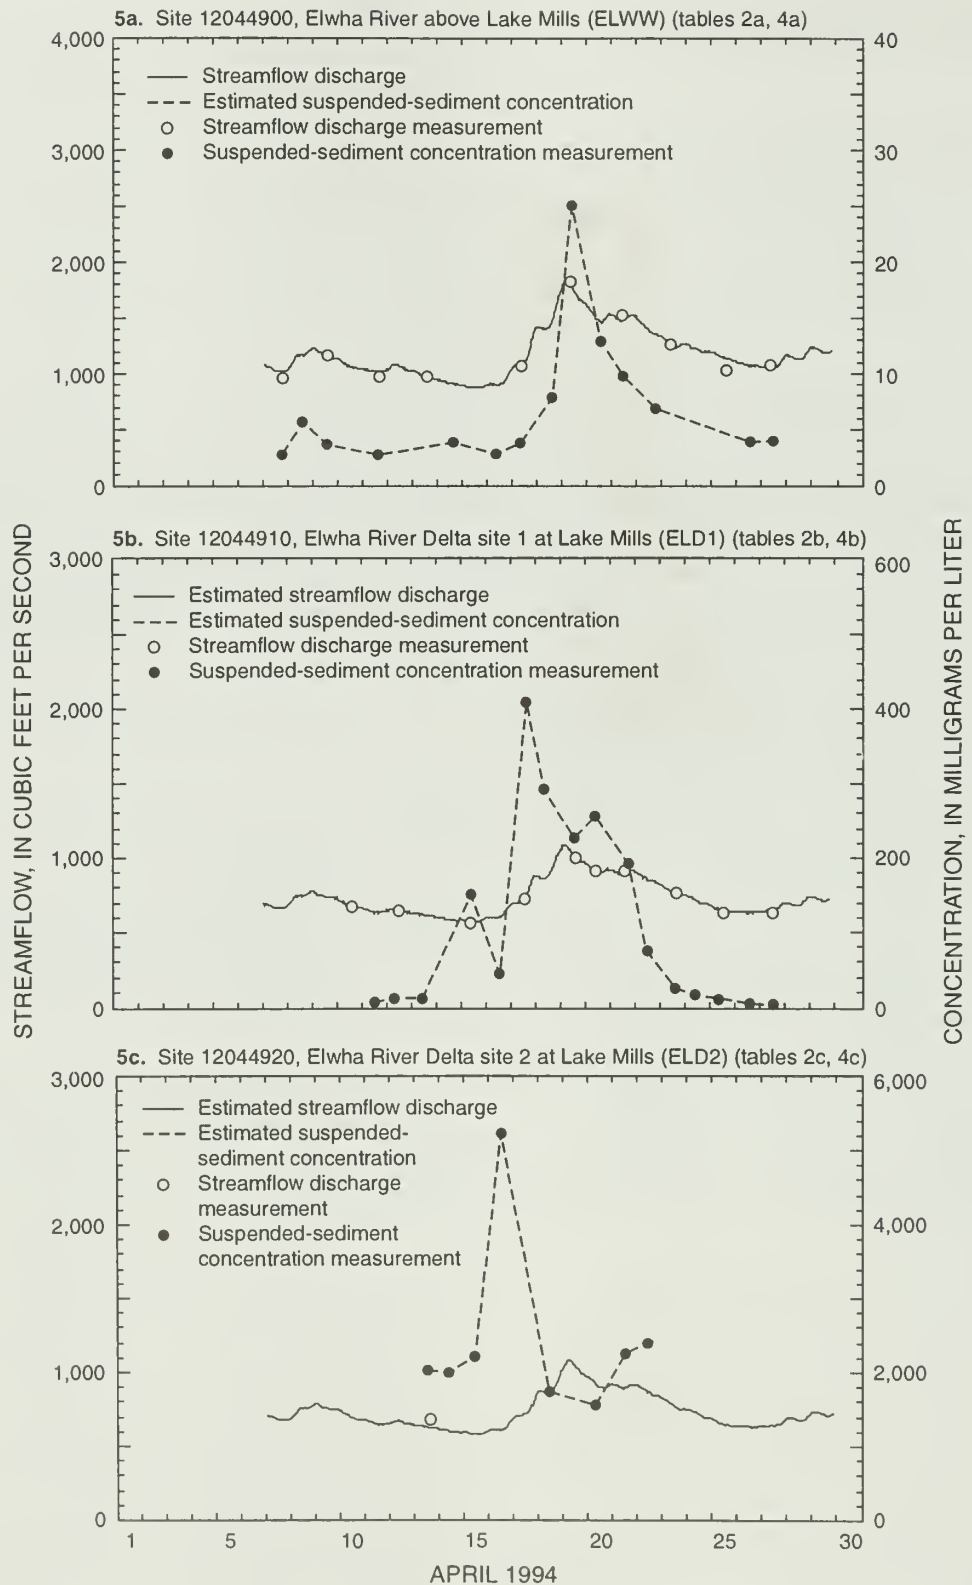
Figure 5a-c. Continuous record of streamflow and suspended-sediment concentration, instantaneous measurements of streamflow, and suspended-sediment samples at sites on the Elwha River, Washington. Whenever two consecutive samples were collected on the same day at a site, the average suspended-sediment concentration of the two samples is plotted.

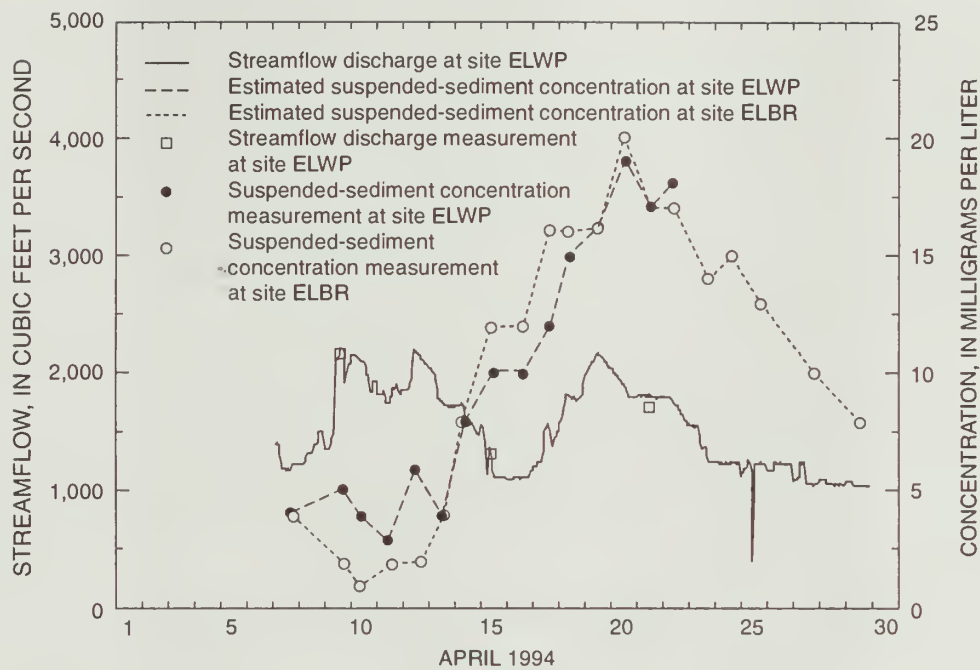
Figure 5d. Continuous record of streamflow and suspended-sediment concentration, instantaneous measurements of streamflow, and suspended-sediment samples at site 12045500, Elwha River at McDonald Bridge (ELWP); and continuous record of suspended-sediment concentration and suspended-sediment samples at site 12045200, Elwha River at Altaire Bridge (ELBR) (tables 2d, 4d, 4e). Whenever two consecutive samples were collected on the same day at a site, the average suspended-sediment concentration of the two samples is plotted.

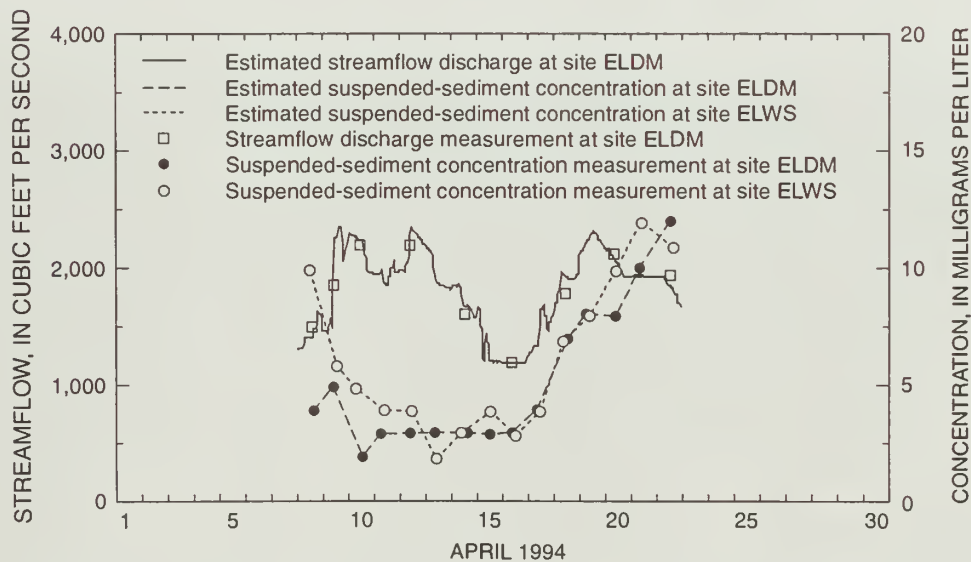
Figure 5e. Continuous record of streamflow and suspended-sediment concentration, instantaneous measurements of streamflow, and suspended-sediment samples at site 12046100, Elwha River below Elwha Dam (ELDM); and continuous record of suspended-sediment concentration and suspended-sediment samples at site 12046300, Elwha River diversion below Elwha Dam (ELWS) (tables 2e, 4f, 4g). Whenever two consecutive samples were collected on the same day at a site, the average suspended-sediment concentration of the two samples is plotted.

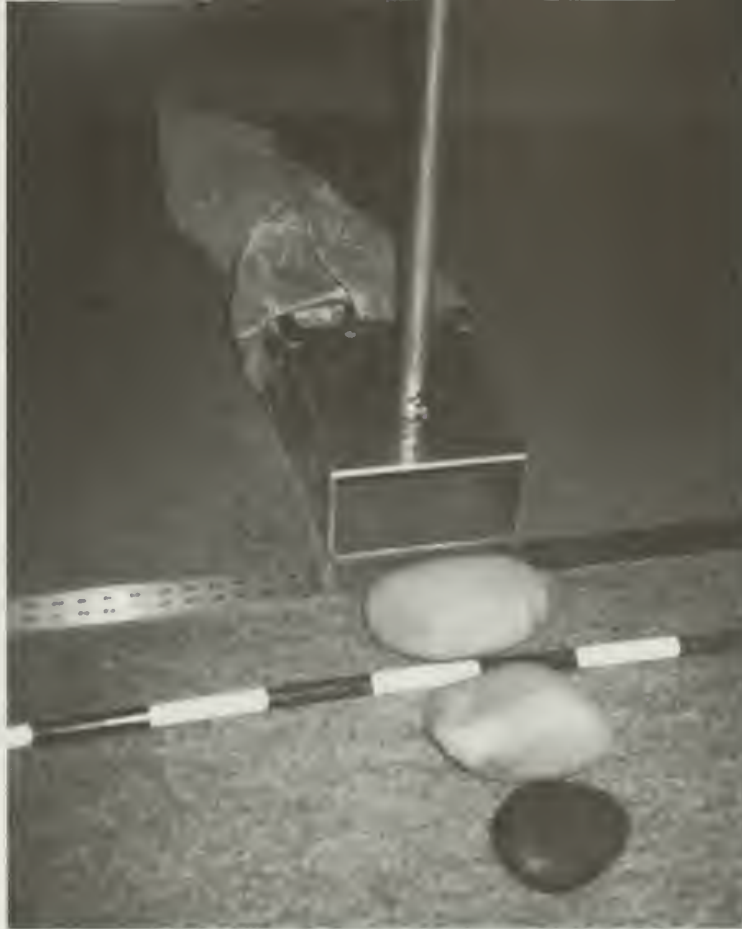
Figure 6. Sampler used to collect Elwha River bedload samples. Rod in middle foreground is marked in 10-centimeter increments.

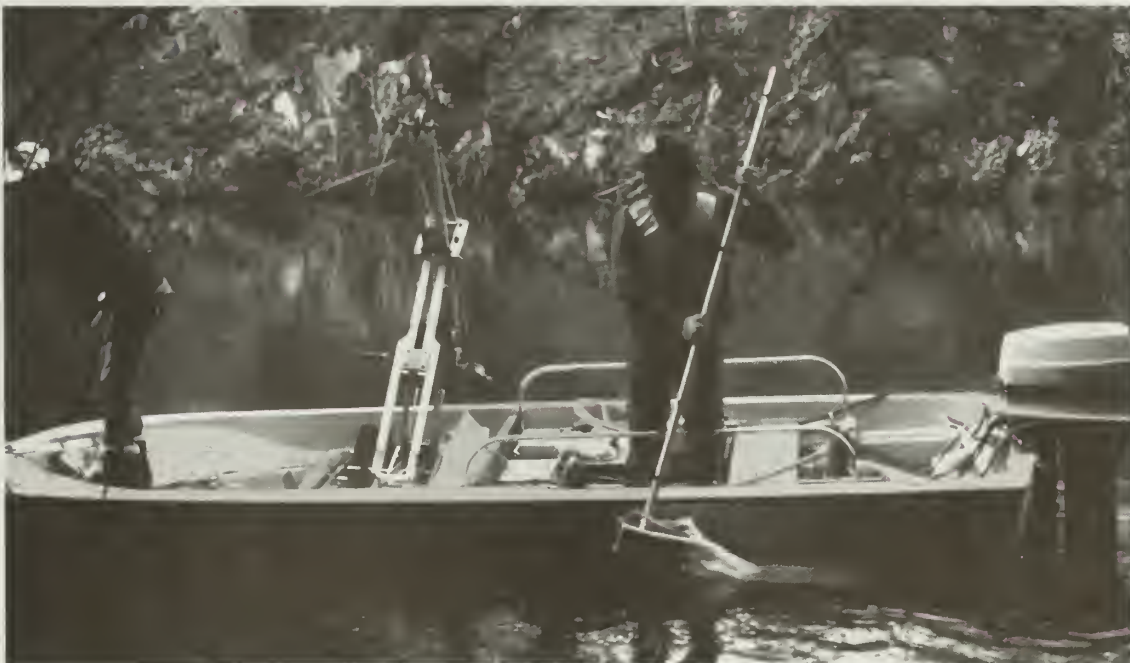
Figure 7. Sampling bedload at site 12044900, Elwha River above Lake Mills (ELWW), from a boat using a tether line attached to the boat gunnel.

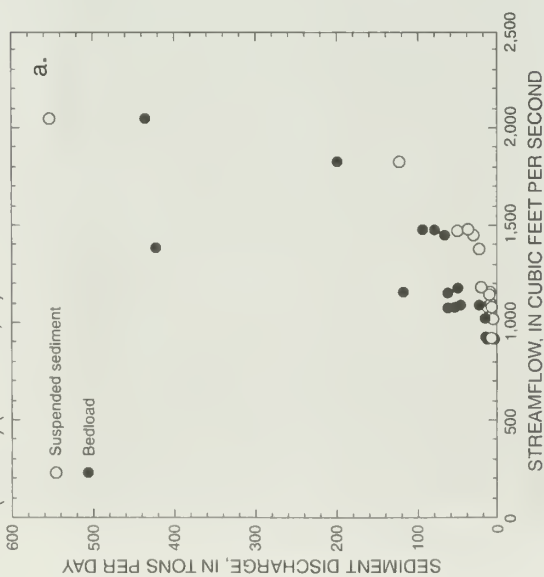
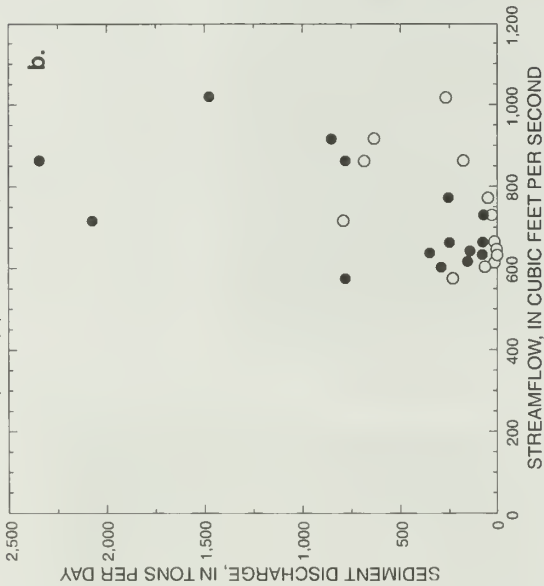
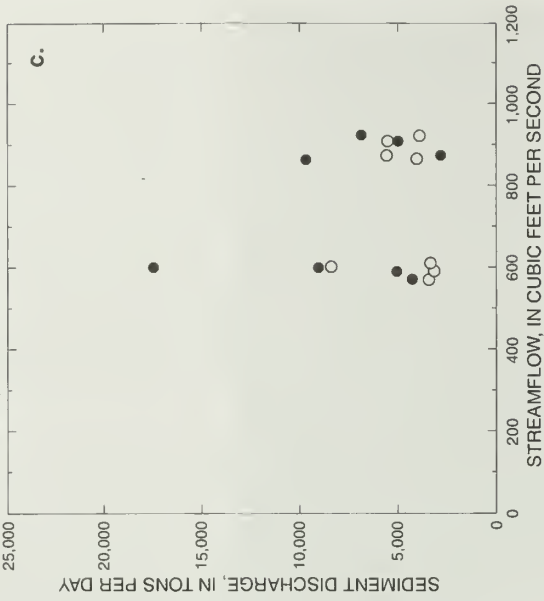
a. and d. Site 12044900, Elwha River above Lake Mills (ELWW) (tables 4a, 6a)

b. and e. Site 12044910, Elwha River Delta site 1 at Lake Mills (ELD1) (tables 4b, 6b)

c. and f. Site 12044920, Elwha River Delta site 2 at Lake Mills (ELD2) (tables 4c, 6c)

Figure 8a-c. Suspended-sediment and bedload discharges for samples collected at selected sites. Whenever two or more consecutive samples were collected on the same day, the average sediment discharges of the samples collected were used to calculate the values shown on the graph.

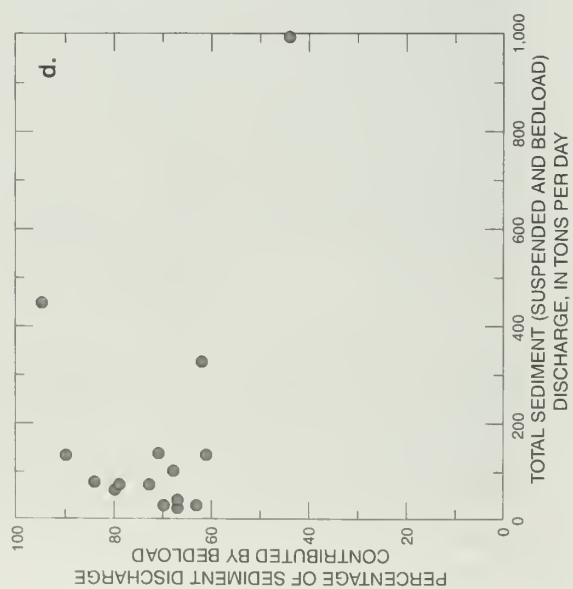
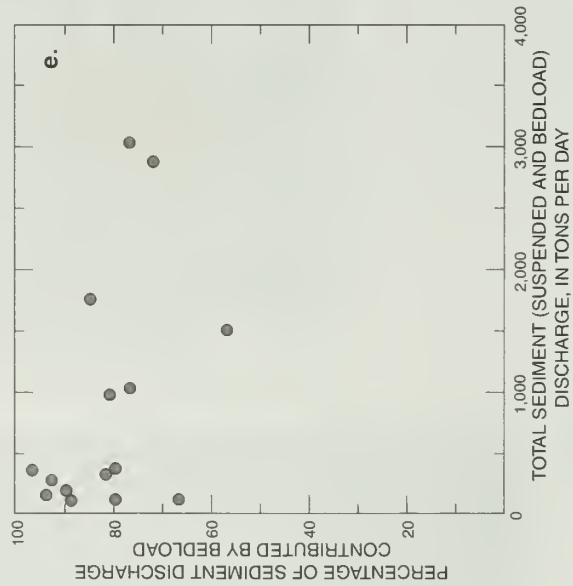
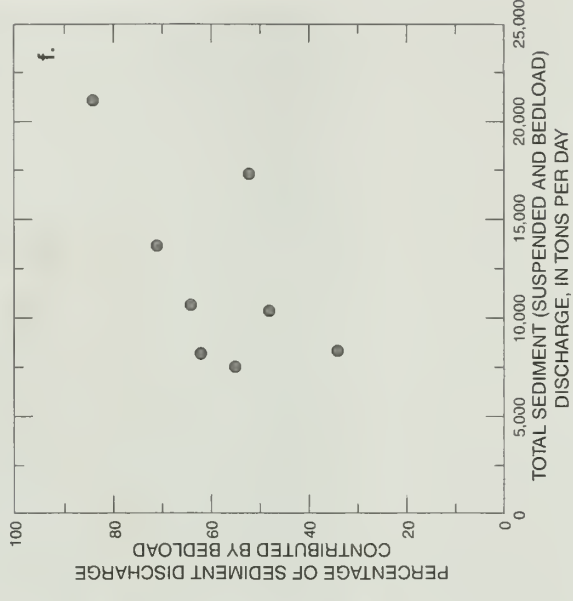
Figure 8d-f. Percentage of total sediment discharge that is contributed by bedload for samples collected at selected sites. Whenever two or more consecutive samples were collected on the same day, the average sediment discharges of the samples collected were used to calculate the values shown on the graph.

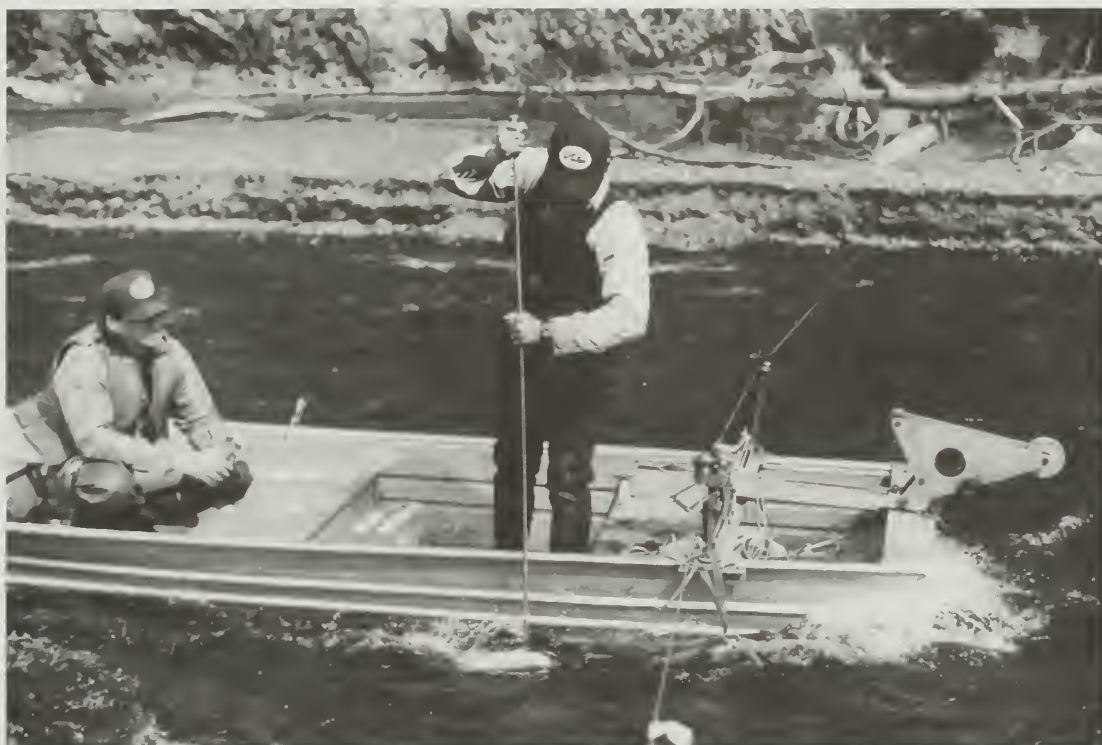
Figure 9. Suspended-sediment sampling using a long wading rod and a DH-48 suspended-sediment sampler from a boat at site 12044910, Elwha River Delta site 1 at Lake Mills (ELD1).

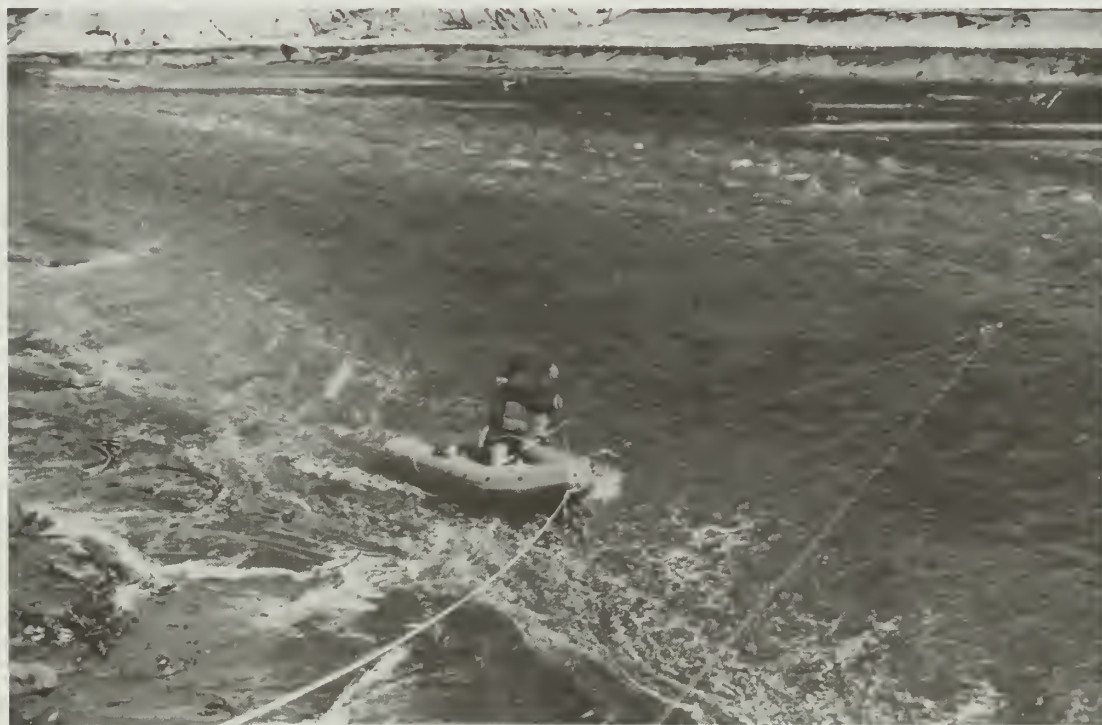
Figure 10. Suspended-sediment sampling using a standard wading rod and a DH-48 suspended-sediment sampler from a boat at site 12044920, Elwha River Delta site 2 at Lake Mills (ELD2).

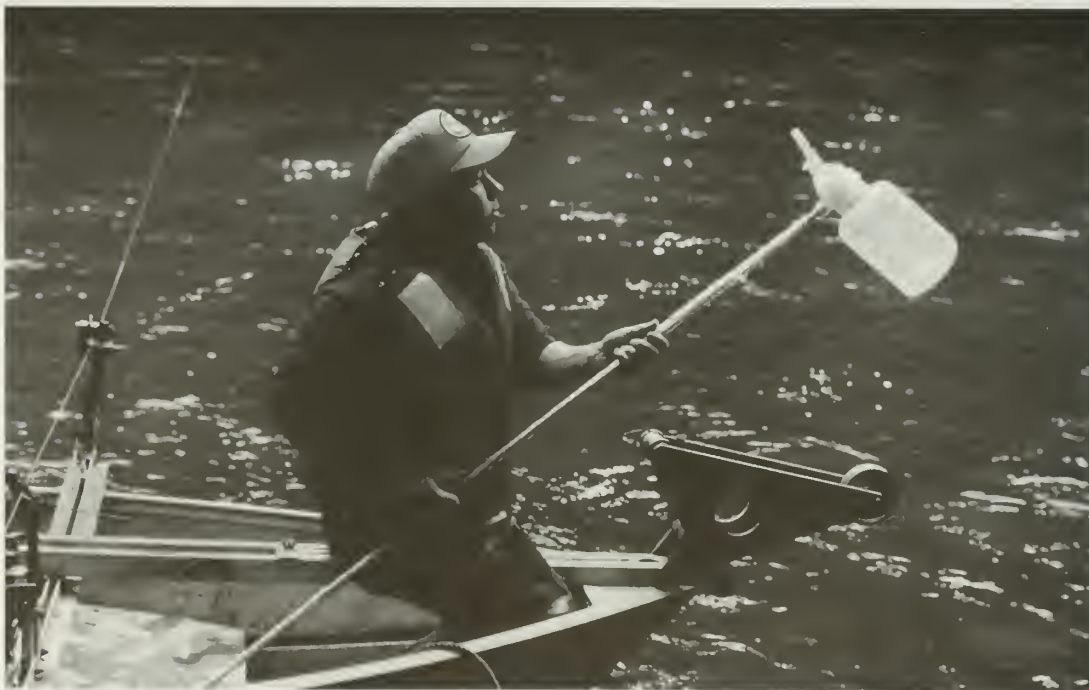
Figure 11. Wading-rod-mounted DH-81 water-quality and suspended-sediment sampler.

Protocols for sampling low-level dissolved constituents (Horowitz and others, 1994) were followed during sampling. At ELWW, ELD2, and ELDM, a wading-rod-mounted DH-81 water-quality sampler, with teflon cap, nozzle, and sample bottle, was used from the front of a boat, which was anchored to a boat tagline (photo, fig. 11). At ELWP, a D-77 sampler, with teflon cap, nozzle, and sample bottle, was suspended from a reel in a cable car.

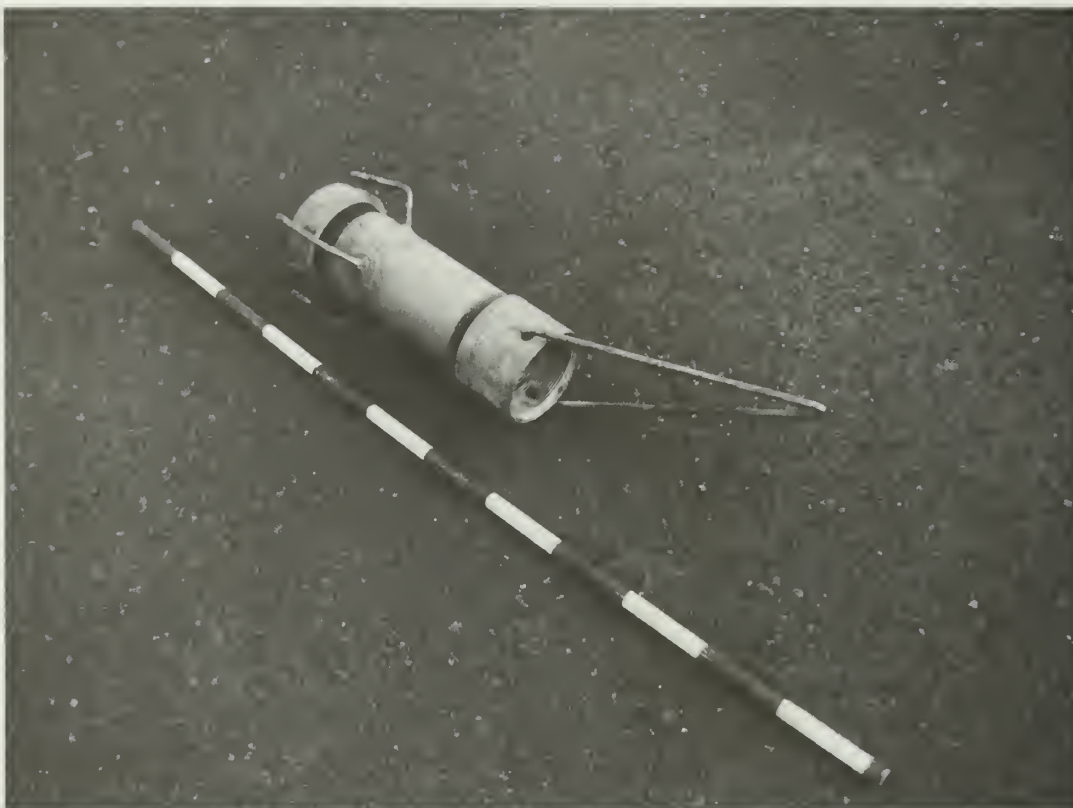
Figure 12. Three-inch (76 millimeters) pipe dredge used to collect bed-material samples. All bed material collected was finer than 45 millimeters. Rod is marked in 10-centimeter increments.

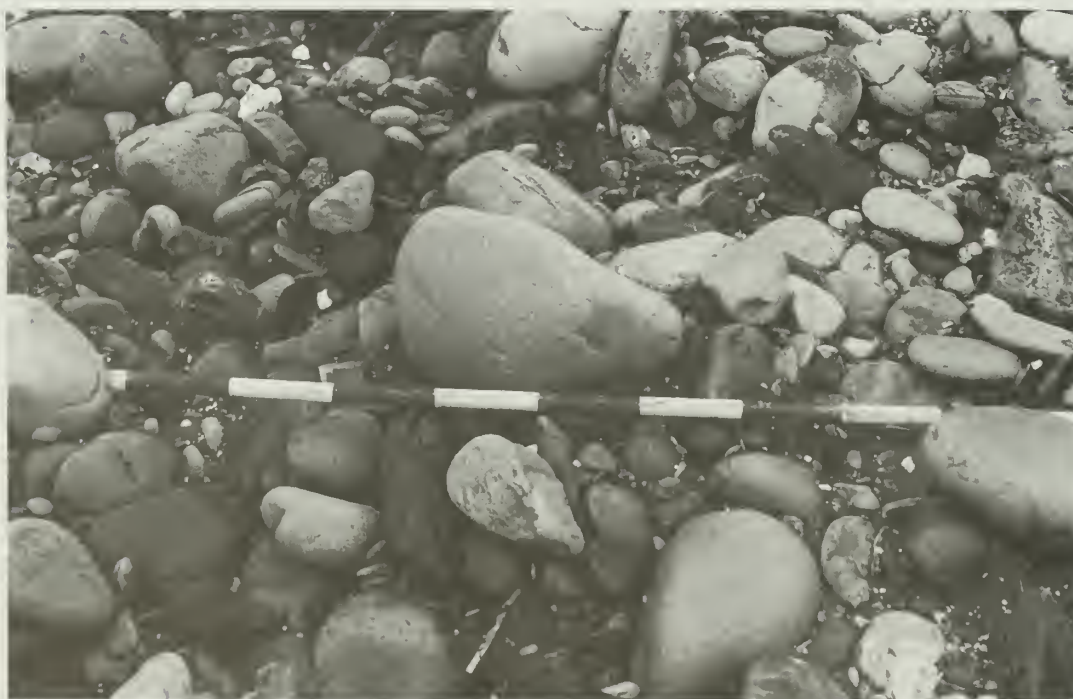
Figure 13a. Gravel bar surface near site 12044910, Elwha River Delta site 1 at Lake Mills (ELD1). Rod is marked in 10-centimeter increments.

Particle counts, each consisting of 200 sampling points, were collected from the surface of the upstream and downstream ends of the left bank gravel bar near ELWW. About 300 sampling points were included in particle-count measurements at the upstream end and midpoint of the left bank gravel bar near ELD1. Bulk samples of subsurface sediment were collected with each particle count. The particle-size distributions of the sediments in the surface and subsurface samples are given in tables 9a and 9b. The photographs in figures 13a and 13b show the surface armoring of the

streambed by fine to coarse gravel and the finer sediment found below the surface of the left bank gravel bar near ELD1.

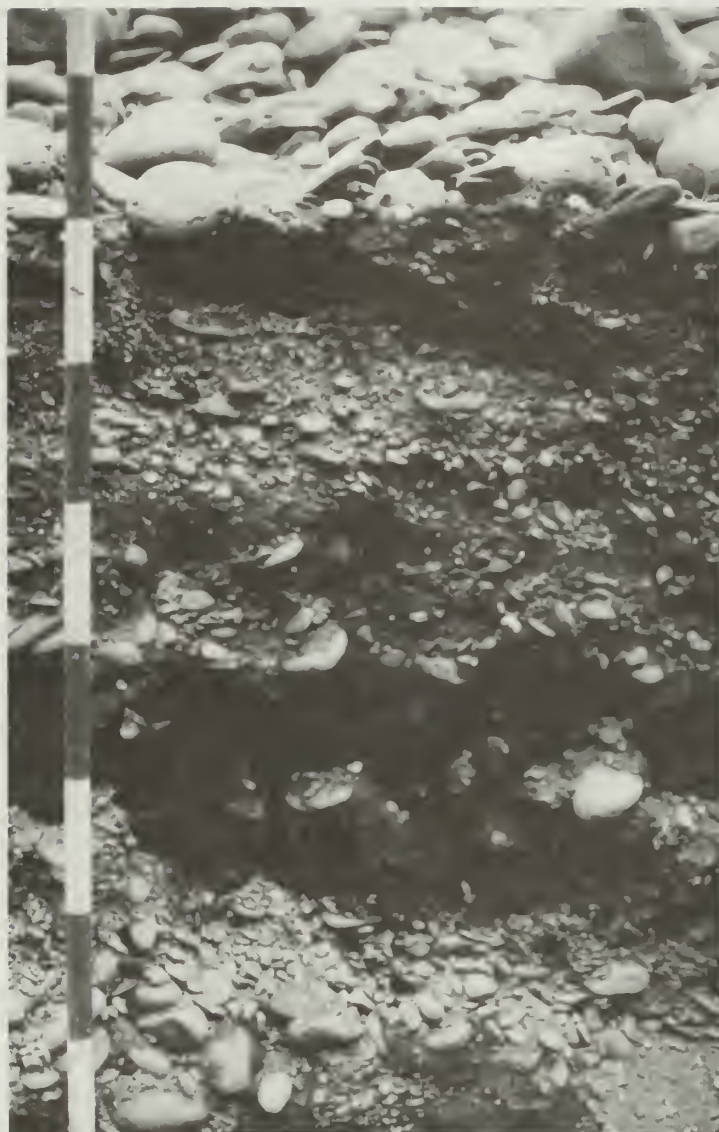
Figure 13b. Cut bank showing surface armoring and finer-grained subsurface sediment near site 12044910, Elwha River Delta site1 at Lake Mills (ELD1). Rod is marked in 10-centimeter increments.

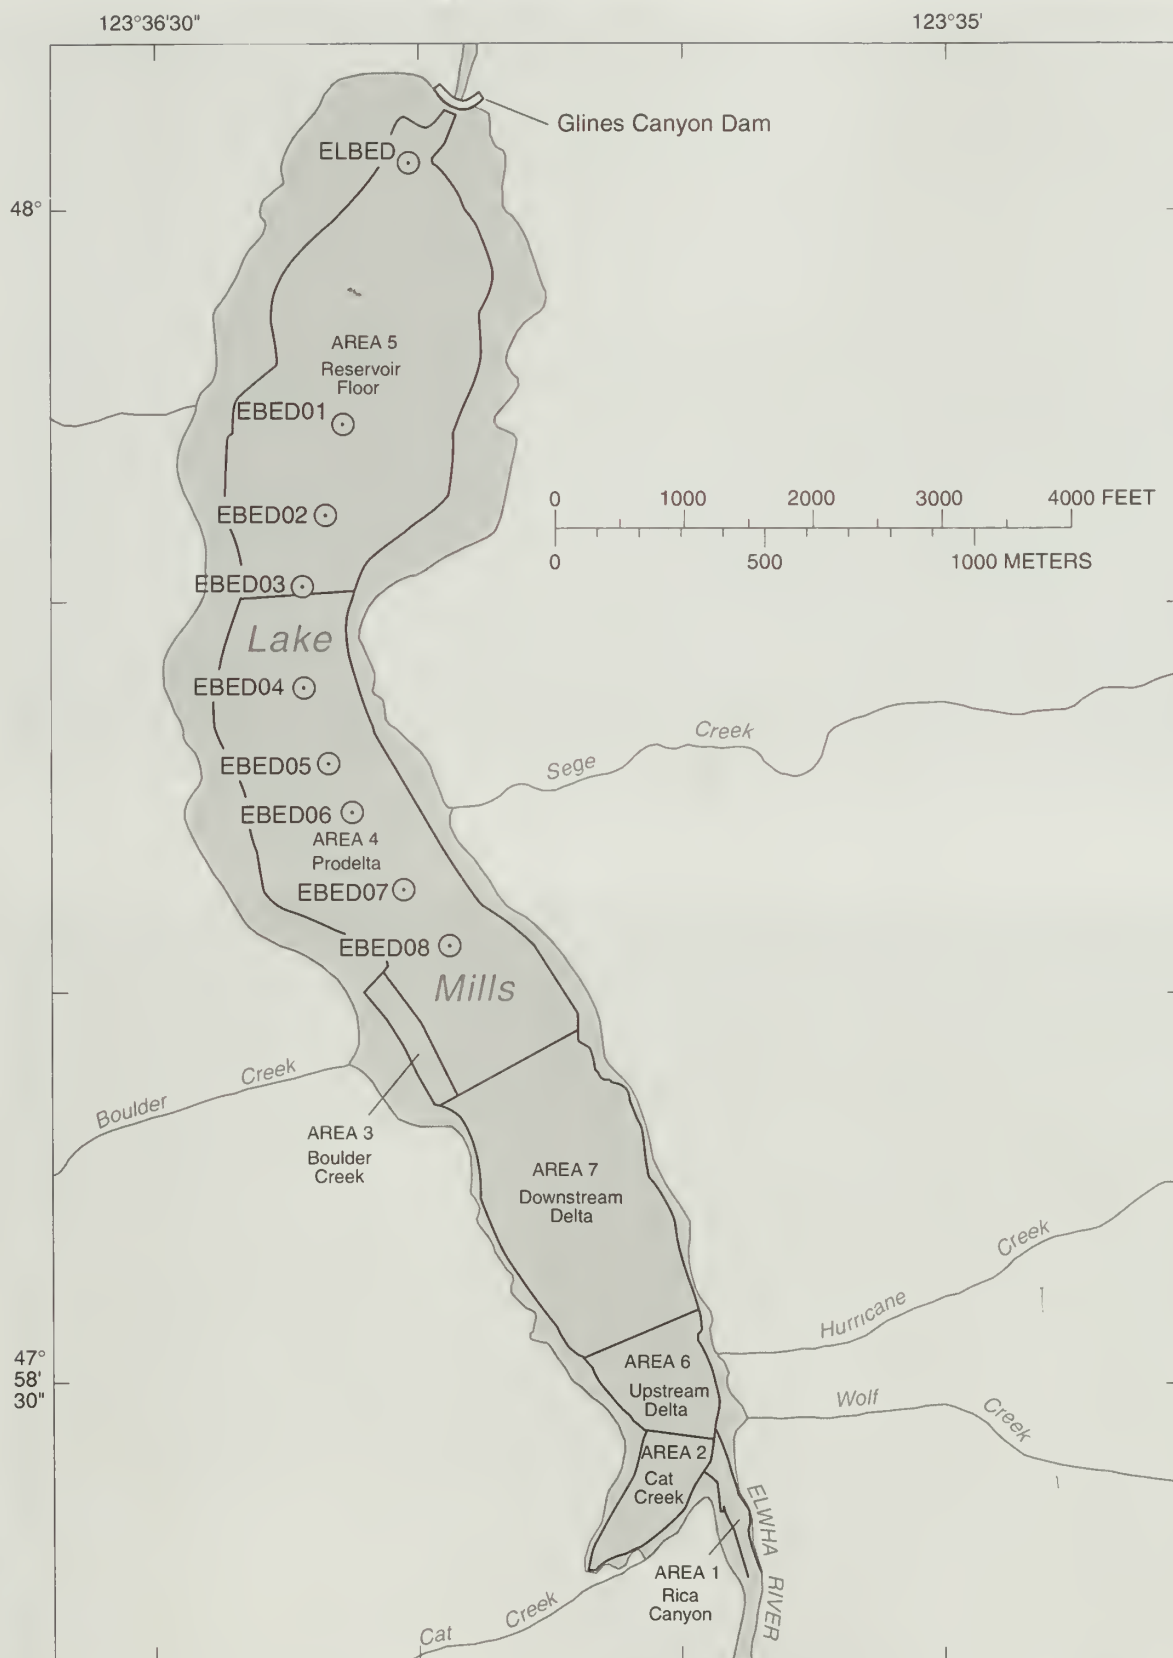
Figure 14. Lake Mills sedimentation areas (modified from Gilbert and Link, 1995, figure 6), and locations of lakebed samples ELBED (table 7e) and EBED01-EBED08 (table 12).

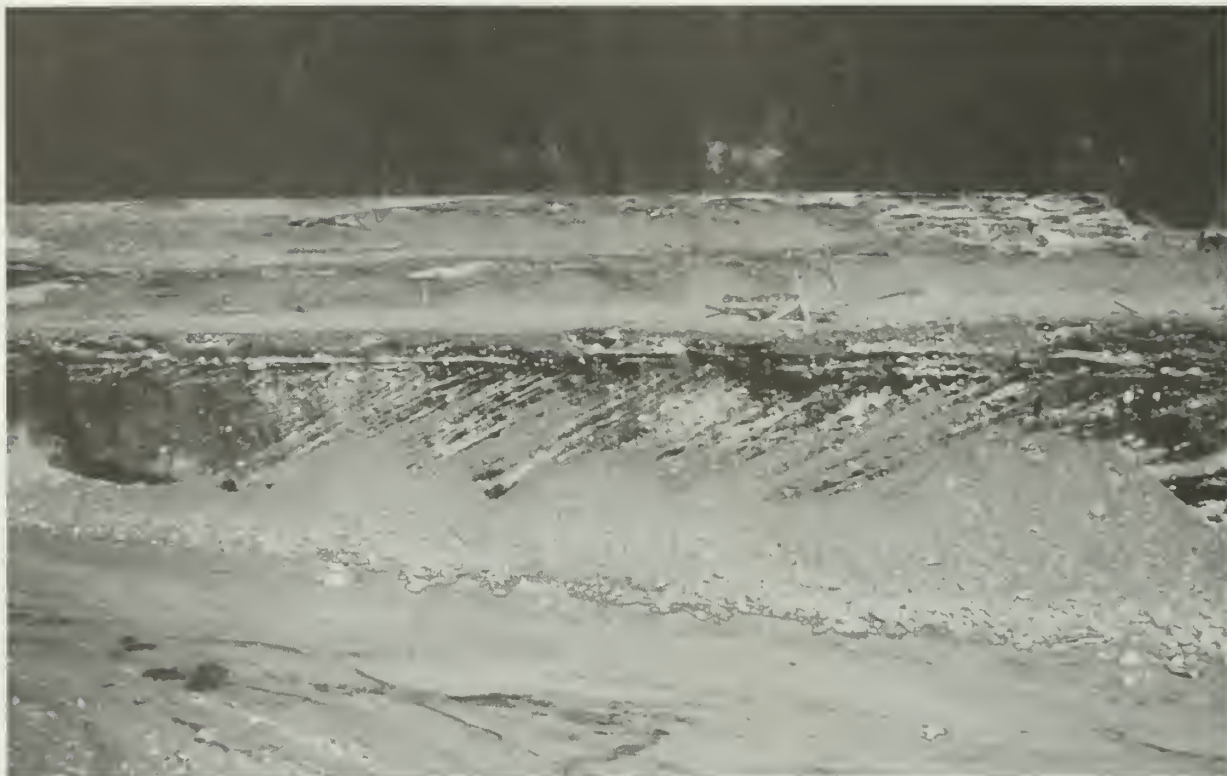
Figure 15. Topset beds overlying foreset beds near site 12044920, Elwha River Delta site 2 at Lake Mills (ELD2).
